FEBRUARY 2022

TECHNICAL MEMO

EXISTING AND FUTURE NO-BUILD CONDITIONS

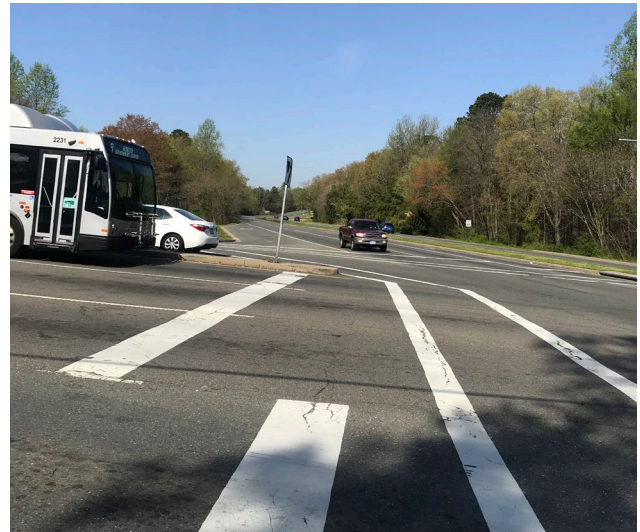
Figure 23. Skewed Crosswalk at E. Parham Road and Hungary Spring Road

Sidewalks and crosswalks are limited throughout the study area. Only two of the study intersections provide crosswalks for people walking, including Dumbarton Road and Lakeside Avenue and E. Parham Road and Hungary Spring Road. As shown in **Figure 23**, existing crossings at E. Parham Road and Hungary Spring Road are skewed, provide poor sight distance, and lack pedestrian refuges.

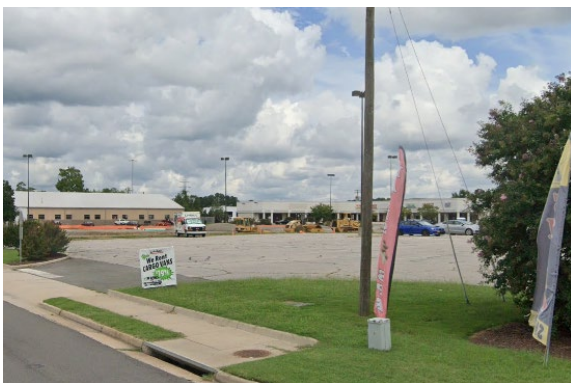
Figure 24 Sidewalk Gaps on Staples Mill Road near Hilliard Road

Although sidewalks are provided along the entire length of Staples Mill Road, none of the study intersections have marked crosswalks to facilitate pedestrian crossings at intersections. Additionally, the existing sidewalks lack proper maintenance and improved ADA accessibility. **Figure 24** shows an abrupt sidewalk end near Hilliard Road, along Staples Mill Road at the Family Dollar. Without a continuous sidewalk or safe crosswalks, pedestrians experience unsafe and uncomfortable conditions. **Figure 25** displays overgrown shrubs and poor maintenance that poses ADA challenges on the sidewalk near the Dumbarton Square Shopping Center.

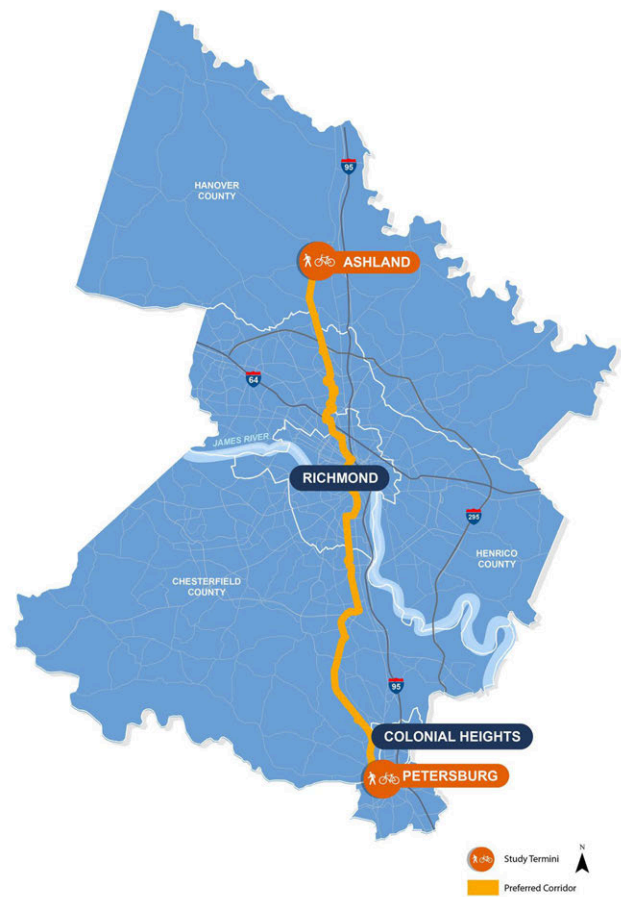
Figure 33. Proposed Fall Line Trail

The Fall Line Trail is a proposed 43-mile-long multiuse paved path connecting Ashland to Petersburg, as shown in **Figure 33**. The path generally follows U.S. Route 1 and crosses over multiple municipalities, including Henrico, Hanover, and Chesterfield counties, the town of Ashland, and the cities of Richmond, Colonial Heights, and Petersburg.

1. **Lakeside Community Trail Phases 1–3 (1.6 miles) from Spring Park to Hilliard Road**
2. **Brook/Hilliard Road Diet (0.5 miles) from Belmont Golf Course to Lakeside Avenue**
3. **Villa Park Phase (1.1 miles) from Lakeside Boulevard to E. Parham Road**
4. **Longdale Trail (3.2 miles) from E. Parham Road to Woodman Road Extension**

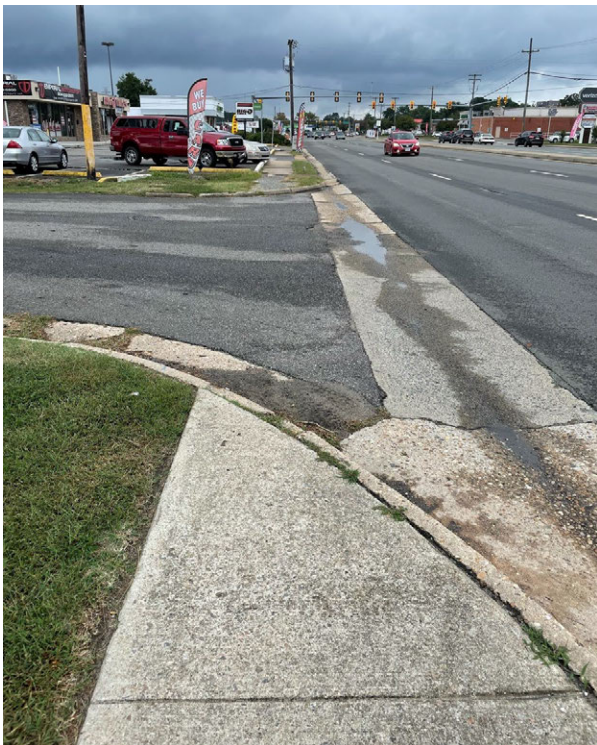
Figure 36. Challenges for Wheelchair Accessibility

Seven of 11 corridor bus stops (64%) have obstacles impeding access by wheelchair users.

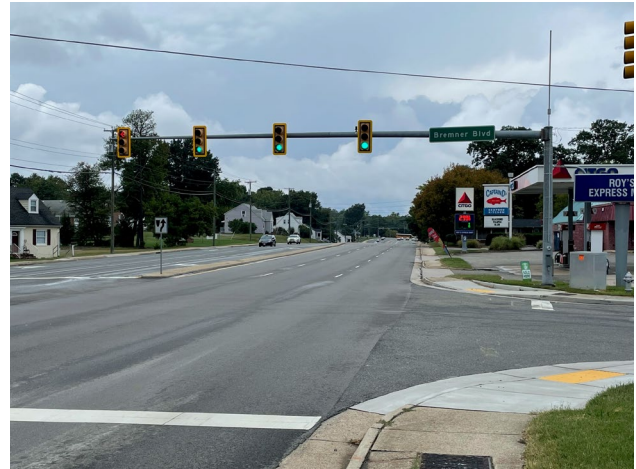
Figure 37. ADA Accessible Curb Ramps

The corridor bus stops that do have ADA accessible curb ramps do not have marked crosswalks (**Figure 37**).

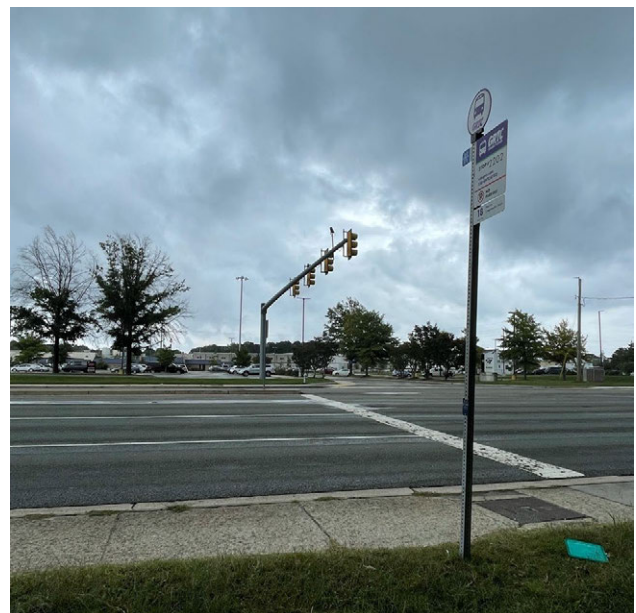
Figure 38. Staples Mills Road Bus Stop with Sidewalk Access and without a Marked Crosswalk (Staples Mill & Amtrak, stop ID 2202)

Although all corridor bus stops are located near or connected to a sidewalk, transit riders do not have a safe means to cross Staples Mill Road to access bus stops or destinations across the road from bus stops (**Figure 38**).
