TEST REPORT FOR:

Virginia Department of Transportation
ET-Plus 50' (15.24 m) System 4" Channel

NCHRP 350

TR-P35107-01-NC

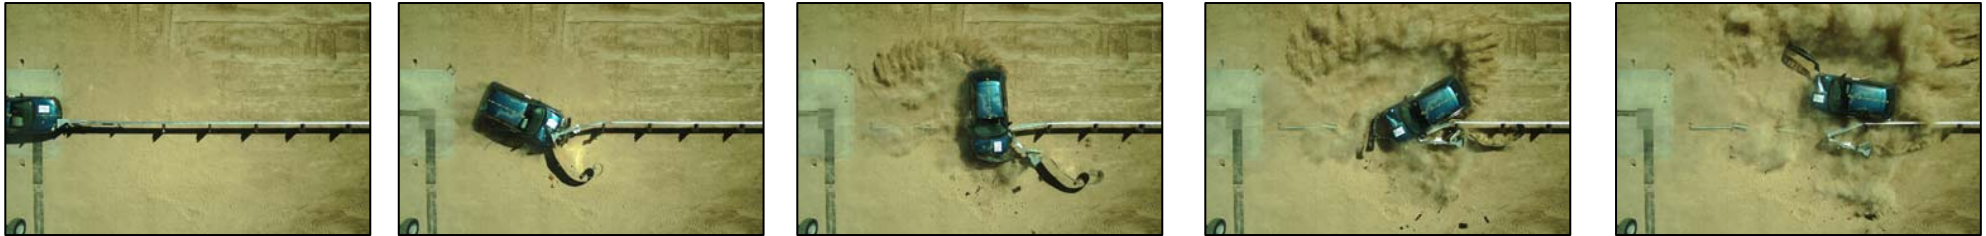
0 ms

250 ms

500 ms

750 ms

1000 ms

GENERAL INFORMATION		OCCUPANT RISK VALUES	
TEST AGENCY	KARCO Engineering, LLC.	FLAIL SPACE VELOCITY (m/s)	
TEST NO.	3-30	X DIRECTION	7.2
DATE	9/18/2015	Y DIRECTION	0.1
TEST ARTICLE		THIV (Optional) (m/s)	7.2
TYPE	Terminal	RIDEDOWN ACCELERATION (g)	
TERMINAL LENGTH ¹	15.2 m (50.0 ft.)	X DIRECTION	-11.0
ADJOINING BARRIER LENGTH ²	34.3 m (112.5 ft.)	Y DIRECTION	10.1
TEST VEHICLE		PHD (Optional) (g)	11.9
TYPE	Production Model	ASI (Optional)	0.78
DESIGNATION	820C	VEHICLE DAMAGE	
MODEL	2000 Geo Metro	EXTERIOR	
MASS (CURB)	815.5 kg (1797.8 lbs)	VDS	12-FC-4
MASS (TEST INERTIAL)	832.5 kg (1835.4 lbs)	CDC	12FZEW1
DUMMY MASS	76.0 kg (167.5 lbs)	INTERIOR	
MASS (GROSS STATIC)	907.0 kg (1999.5 lbs)	OCDI	RF0000000
IMPACT CONDITIONS		POST-IMPACT VEHICULAR BEHAVIOR	
VELOCITY (km/h)	96.82 km/h (60.16 mph)	MAXIMUM ROLL ANGLE (°)	-5.7 ³
ANGLE (°)	0.5	MAXIMUM PITCH ANGLE (°)	-2.4 ³
IMPACT SEVERITY (kJ)	301.0	MAXIMUM YAW ANGLE (°)	186.0 ³

The test vehicle impacted the ET-Plus 50' (15.24 m) System at a velocity of 96.82 km/h (60.16 mph). The test vehicle impacted the ET-Plus extruder head and pushed it down the guardrail before stopping upstream of the third SYTP post. The HBA top post broke away from the HBA bottom post and remained attached to the extruder head. The first two (2) SYTP posts yielded at grade level and bent down to the ground and forward in the direction of vehicle travel. The third SYTP post also yielded at grade level and bent approximately 46° in the direction of vehicle travel. After the vehicle passed the second SYTP post, the guardrail panel kinked and separated at the third SYTP post and the extruder head spun to the non-traffic side of the guardrail. The vehicle spun clockwise toward the traffic side of the guard rail and impacted the rail at the third SYTP post before coming to rest. The test vehicle came to rest approximately 10.5 m (34.5 ft.) forward and 1.4 m (4.7 ft.) left of its position at the point of impact. An overhead illustration of the test vehicle and test article in their pre-test and post-test conditions is shown in Figure 57 in Appendix D. Sequential photographs of the test sequence are shown on Data Sheet 4. The remainder of the posts shifted within the soil foundation. The wooden post of the trailing end terminal treatment cracked and the cable anchor assembly was not taut after the impact.

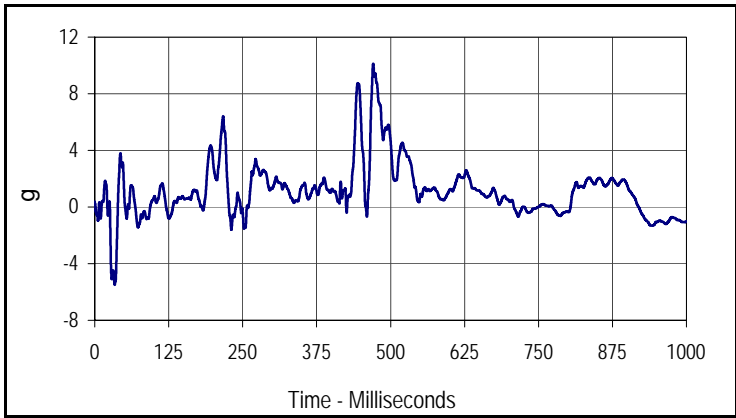
Curve Description			
Test Vehicle CG Y Moving Average			
Plot No.	Type	SAE Class	Units
006	AVG	180	g
Max	Time	Min	Time
10.1	470.6	-5.5	33.8

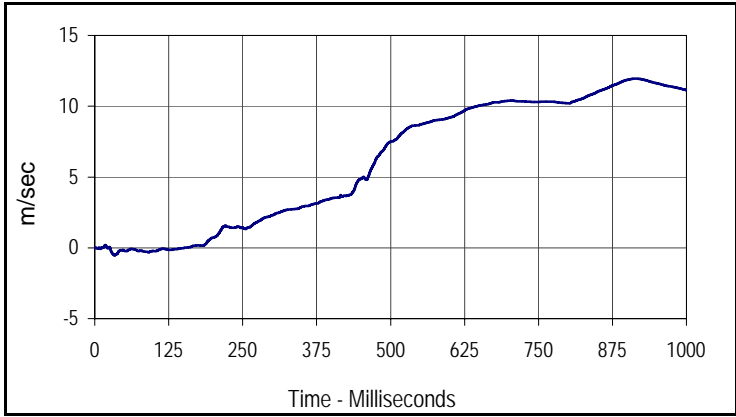
Curve Description			
Test Vehicle CG Y Velocity			
Plot No.	Type	SAE Class	Units
007	IN1	180	m/sec
Max	Time	Min	Time
11.9	914.1	-0.5	33.1

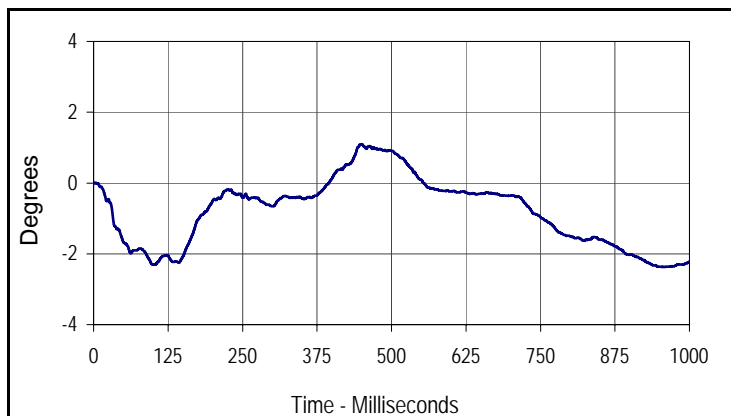
Curve Description			
Test Vehicle Pitch Angle			
Plot No.	Type	SAE Class	Units
013	IN1	180	Degrees
Max	Time	Min	Time
1.1	449.9	-2.4	958.5
