# INTERSTATE 64 PENINSULA STUDY

## NATURAL RESOURCES TECHNICAL MEMORANDUM

OCTOBER 2012

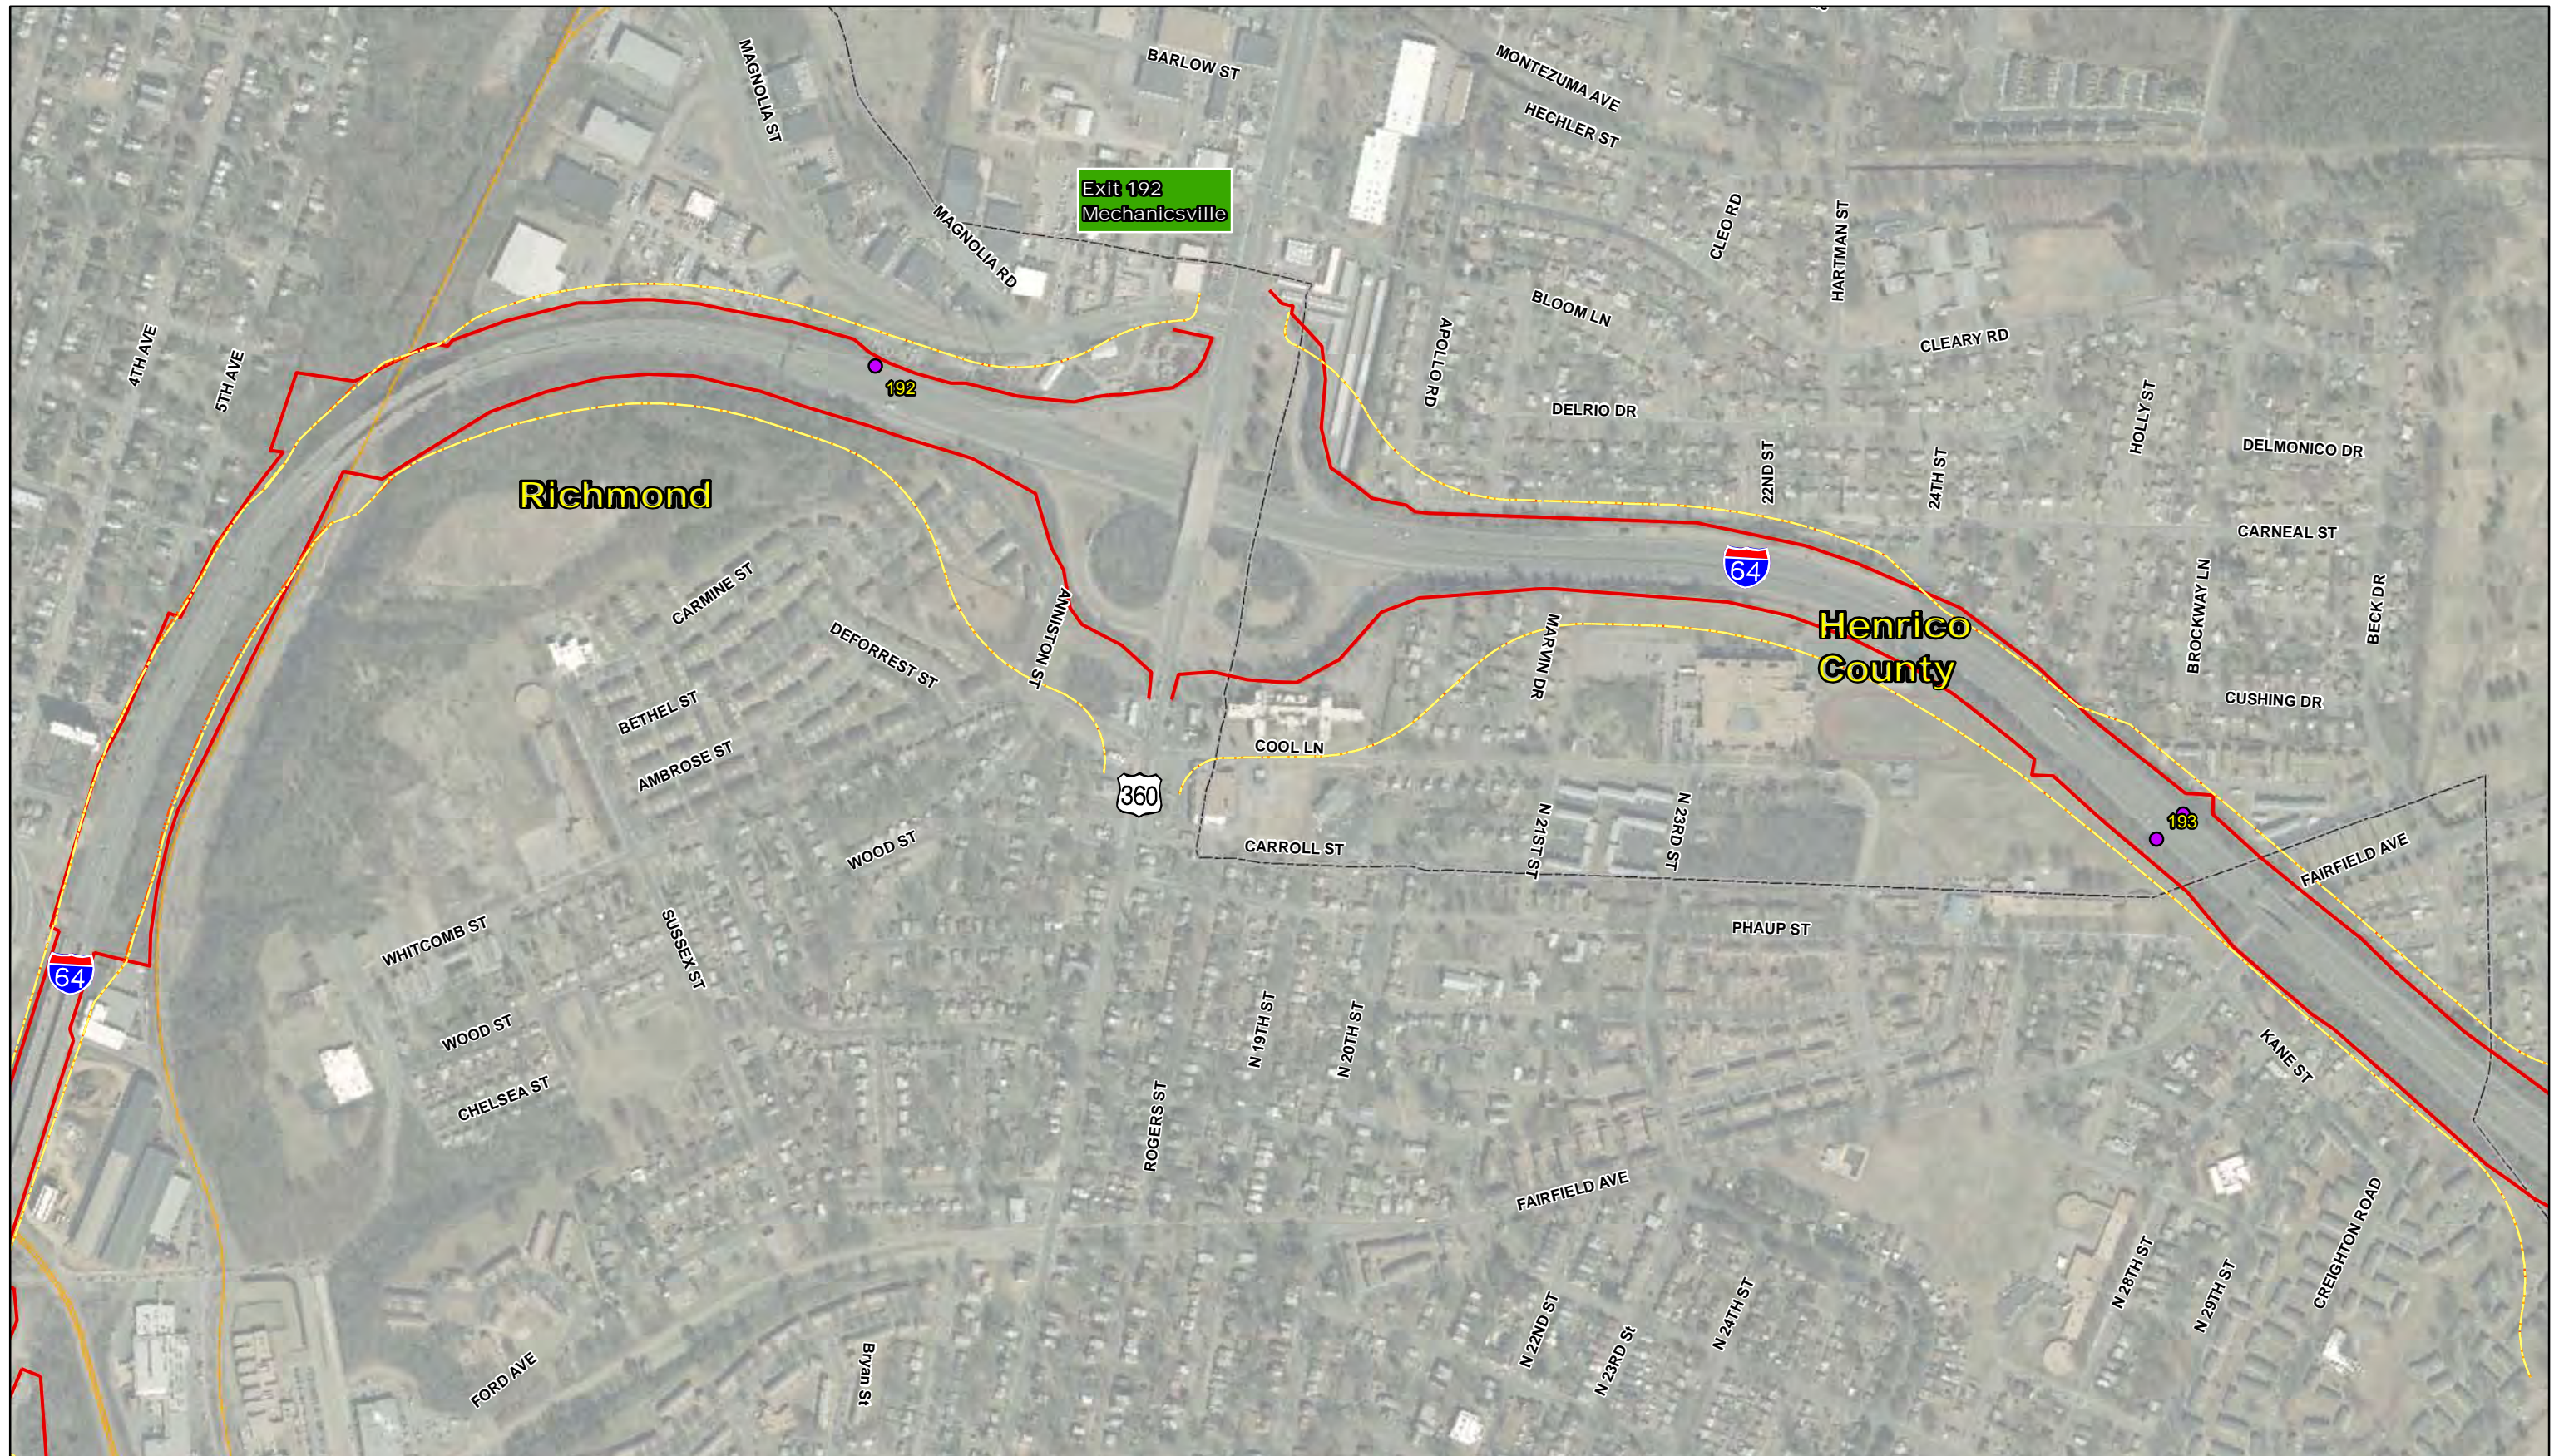
2010 VDEQ Impaired Waters	  Limits of Alternative 1A/2A Footprint
  Locality/ Jurisdiction	  Limits of Alternative 1B/2B Footprint
  Mile Marker	  Limits of Alternative 3 Footprint
	  Limits of Existing Right of Way

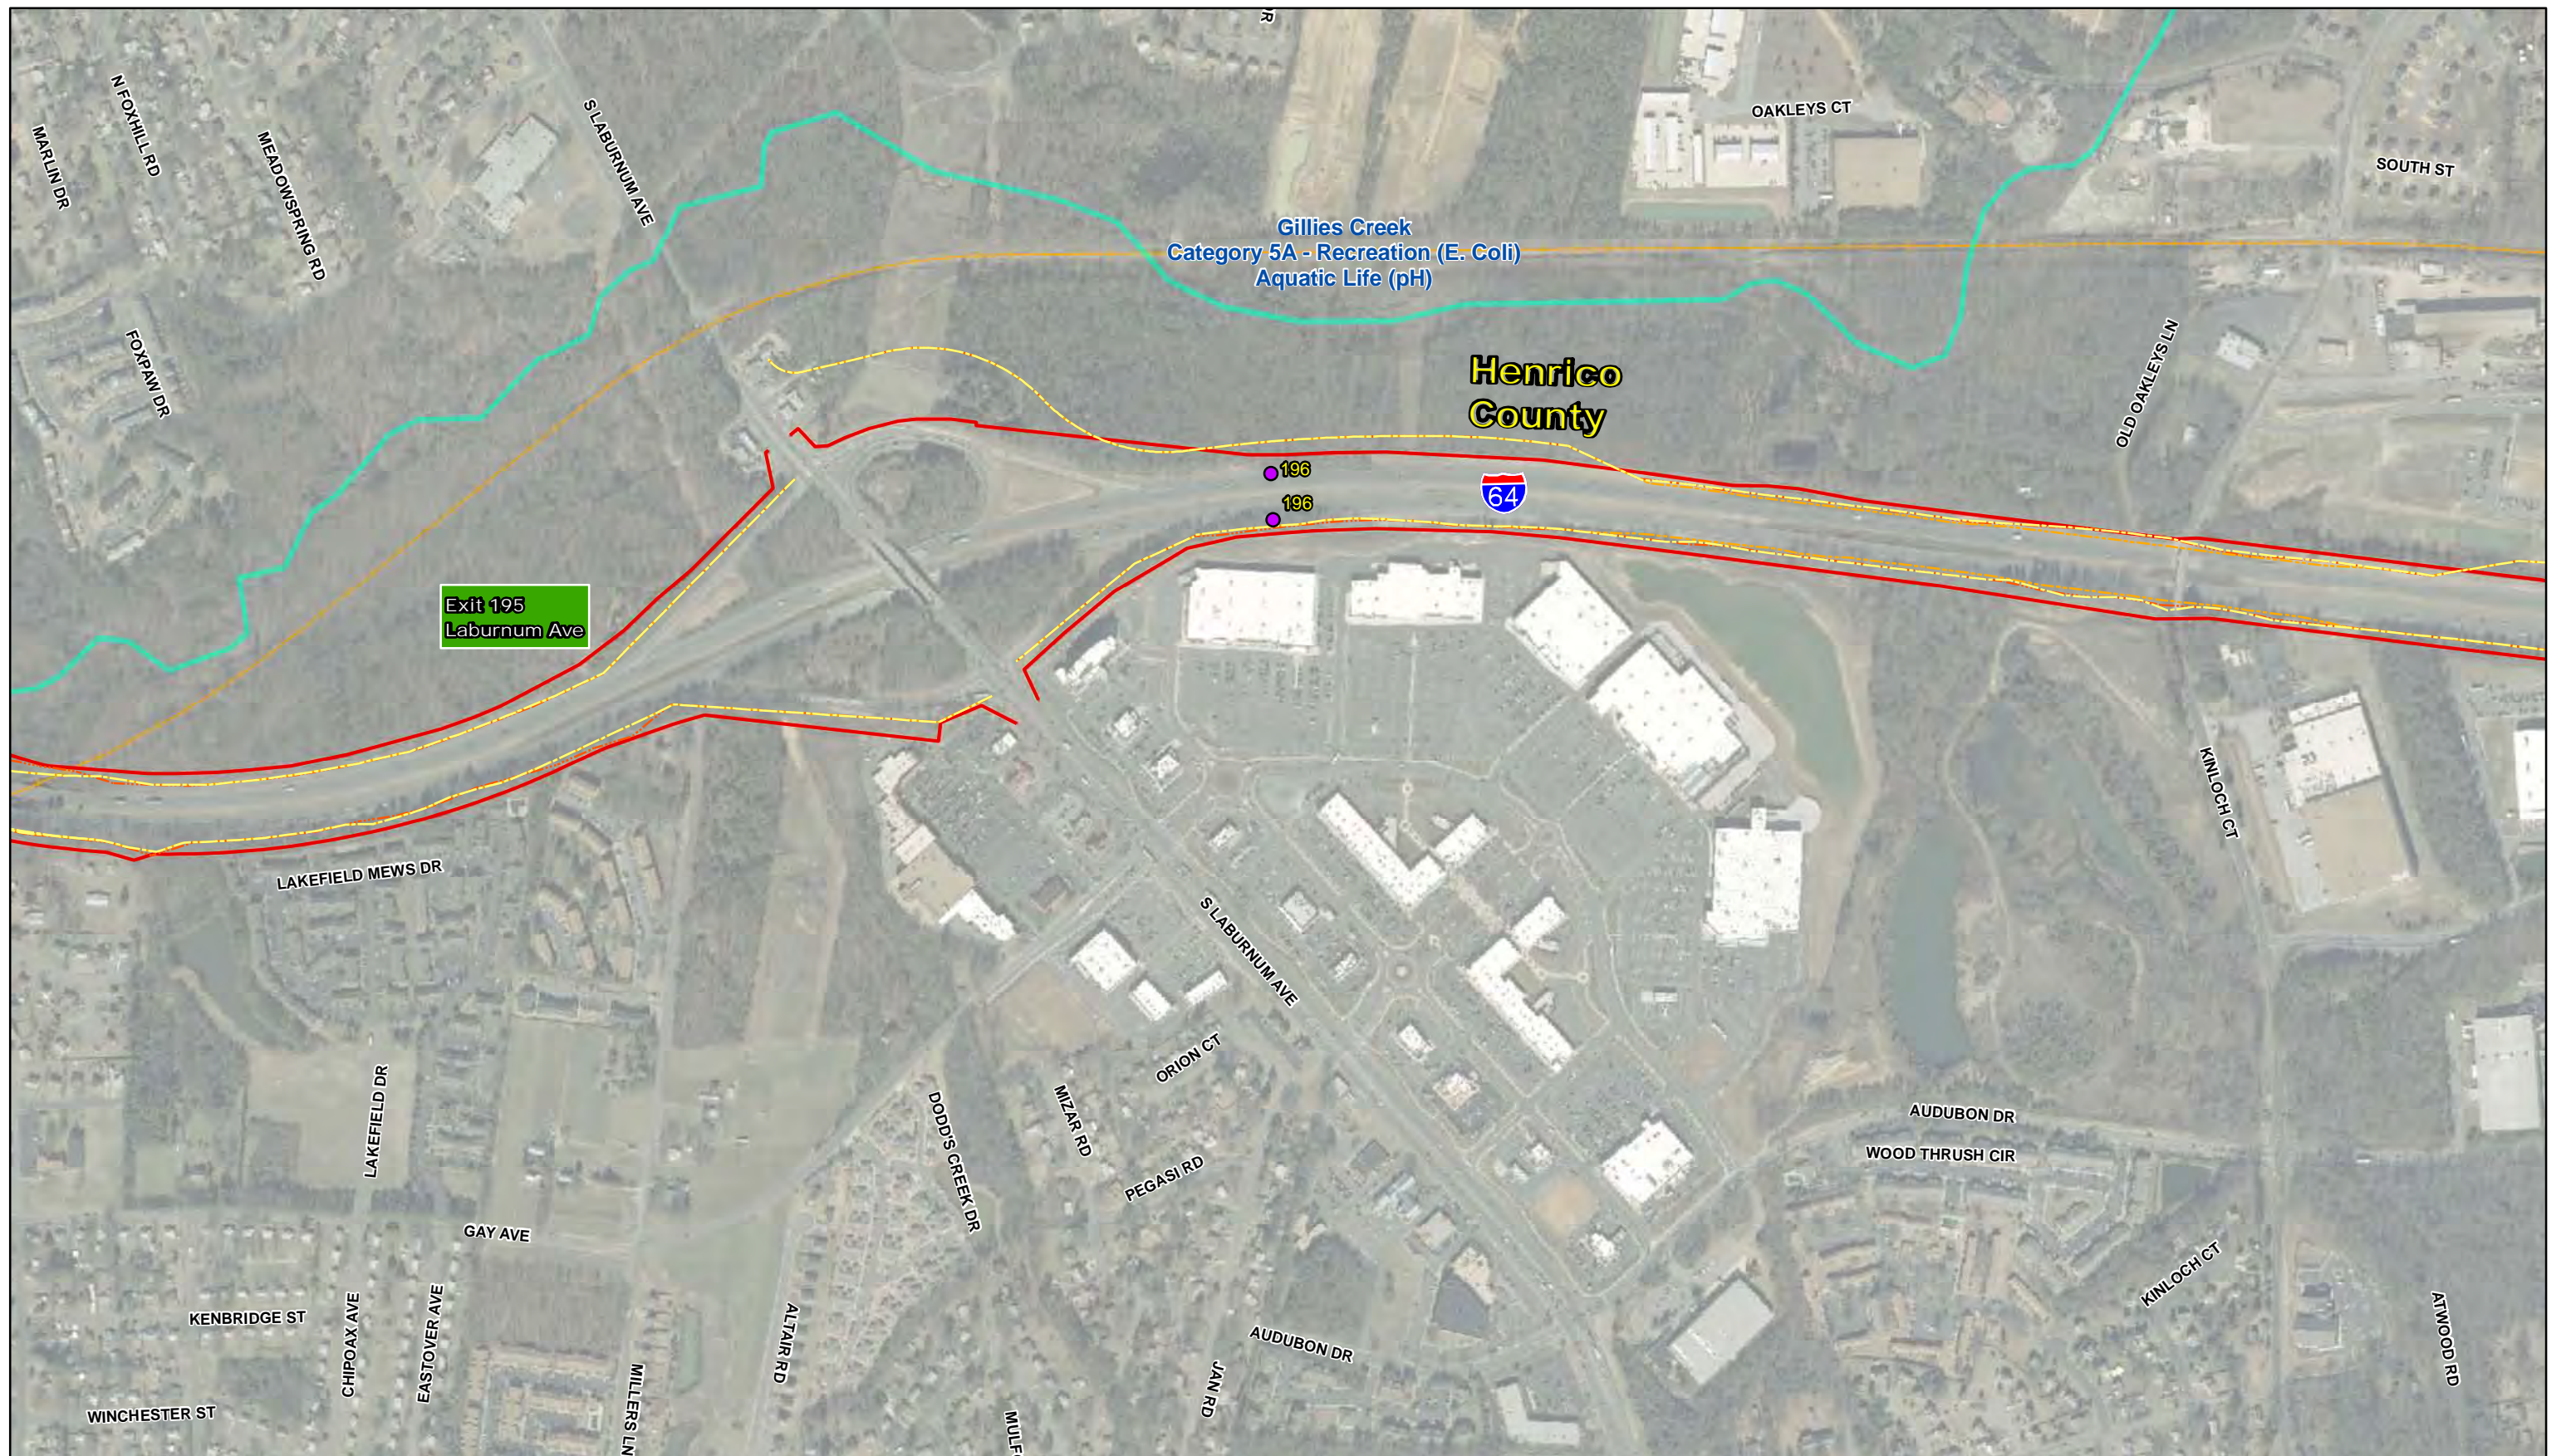
Gillies Creek  
 Category 5A - Recreation (E. Coli)  
 Aquatic Life (pH)
